City Point, London

Case Study

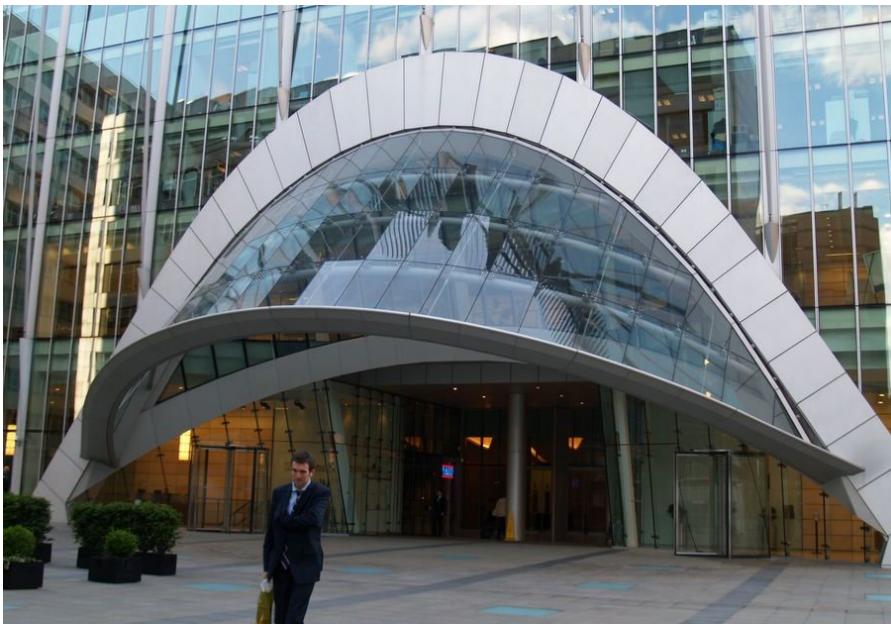
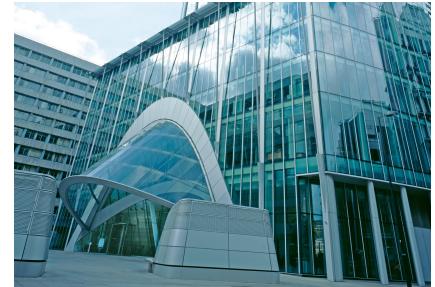
The entrance to serviced offices at City Point in London. A record K41 four wing revolving door has been installed here with the underfloor drive unit connected by a continuous drive shaft. The drum wall consist of glass and all visible components with a brushed stainless steel finish.
